# Manhole Inspection Summary

Manhole # S63O\_\_009MH

Insp Date: **11/24/08 3:15 PM**

**Location** Address: **5501 O'Donnell St. Cut Off**

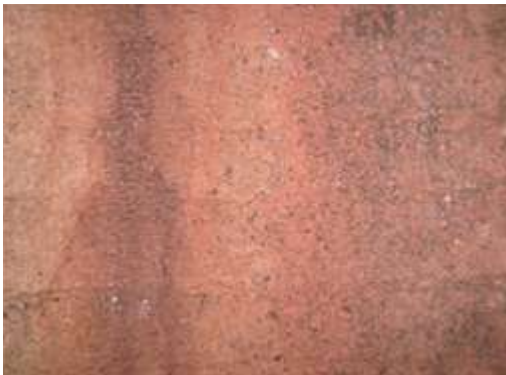
Defect 1

Infiltration on wall.

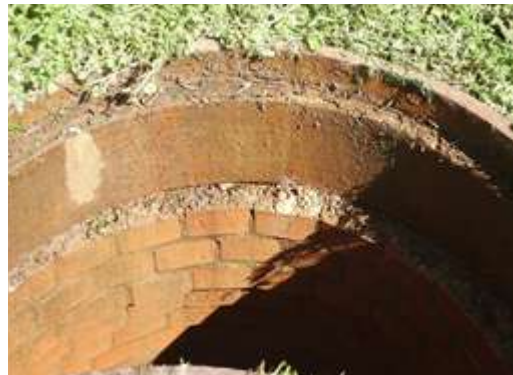
Defect 2

**Frame** Offset: **2** (in.) Condition: ☒ Sound ☐ Cracked ☐ Leaks

offset frame

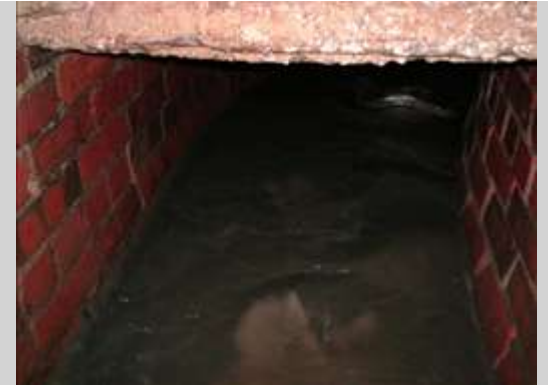
12 O'Clock Outflow

24.0 in. (w) x 24 in. (h) U-shape with flat top Gravity Sewer  
Pipe Out @ 12 O'Clock

Pipe Height: **25.2** (in.) Rod and Bar (Angled)  
Pipe Material: **Clay** ☐ Pipe Lined  
Invert Depth: **19.33** (ft.) Flow Characteristics: **Slow**  
Deposits: ☐ None ☐ Mud ☐ Sludge ☒ **Debris** ☐ Grease  
Silt Depth: **3** (in.) Deposits Extent: **Medium**  
Infiltration: **None** Pipe Seal Cond: **Sound**

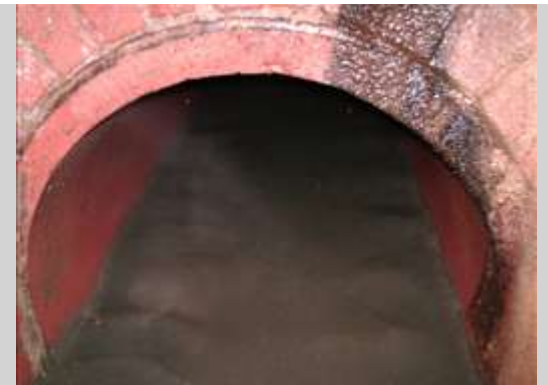
6 O'Clock Inflow

24 in. Circular Gravity Sewer  
Pipe In @ 6 O'Clock

Pipe Height: **25.2** (in.) Rod and Bar (Angled)  
Pipe Material: **Clay** ☐ Pipe Lined  
Invert Depth: **19.08** (ft.) Flow Characteristics: **Slow**  
Deposits: ☒ **None** ☐ Mud ☐ Sludge ☐ Debris ☐ Grease  
Silt Depth: (in.) Deposits Extent:  
Infiltration: **None** Pipe Seal Cond: **Sound**
